Bay Mooring Marina

Shoreline Natural Hazards and Condition Assessment

Shoreline Natural Hazards and Condition Assessment November 2018

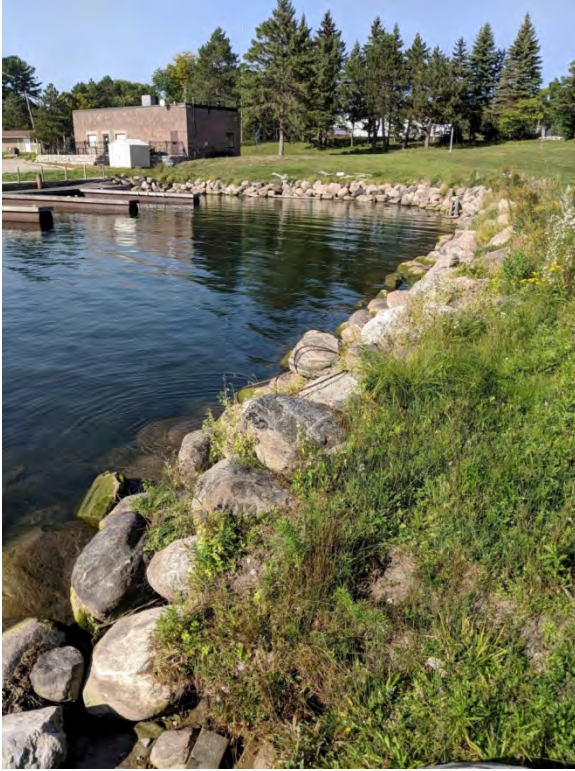
The boulder revetment extends from the east end of Segment 1 on the south side of the marina, reaches to the east approximately 25m and then bends towards the south for approximately 75m. At the end of the revetment segment is another steel sheet pile wall that continues south. It was not inspected. The stones that make up this revetment are approximately 0.7m to 1.0m in diameter. The backshore is vegetated and slopes gently up away from the revetment crest at approximately 10h:1v slope that steepens on the east side as it approaches the adjacent roadway (Photo 1 and Photo 2). The top of the revetment is at an elevation of approximately 178.0m IGLD85 while the roadway is at approximately 181.0m. No signs of instability or erosion in the backshore were noted. However the south end of the revetment before it joins the steel sheet pile wall does have some areas of thin stone cover or missing stones.

The size of the stone in this revetment is appropriate for the wave conditions in this area. However, the crest of the revetment is too low. The design high water level for this area is 178.0m GSC. During a design storm waves will overtop the revetment and there is a risk of erosion in the backshore. Areas of thin stone cover are also susceptible to damage and potentially erosion.

Photo 1 – Revetment

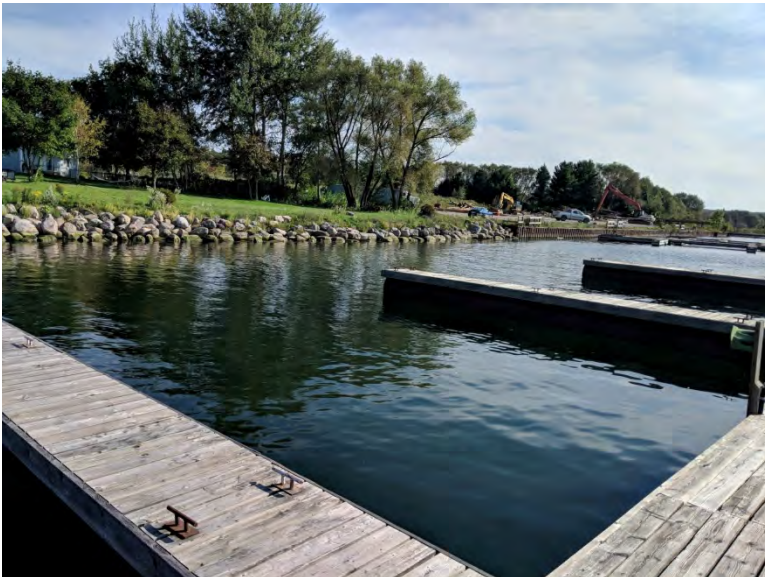
Photo 2 – Revetment

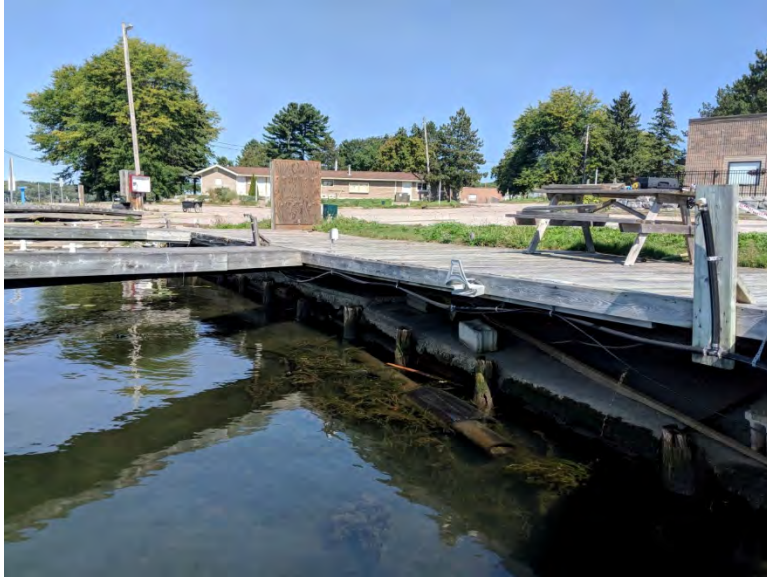
There is a deteriorating concrete slab visible under the timber walkway that runs east-west on this segment as can be seen in Photo 3. It is sitting on top of timber posts and beams that appear to retain the shoreline. Both the concrete and the timber substructure are in severe disrepair; the concrete is cracked while the timber is rotten. The deck level for the walkway is approximately 1m above water level putting it at an elevation of 177.7m IGLD85. The deck itself appears to be supported on steel I-beam sections that sit on top of the concrete slab. Despite

the deterioration of the substructure the timber deck appears mostly level suggesting it was placed after the deterioration of the substructure became an issue.

Both the north-south and east-west portions of this shoreline segment includes structures that have been repaired and/or modified and are at their end of life and will require replacement. The north-south segment does not retain the shoreline effectively and has failed completely along most of its length. Although no signs were seen to suggest loss of fill material in the east-west portion of the backshore, the substructure has failed and its function as a retaining wall is limited.

Photo 3 – Segment 1 – Concrete Cap on Timber

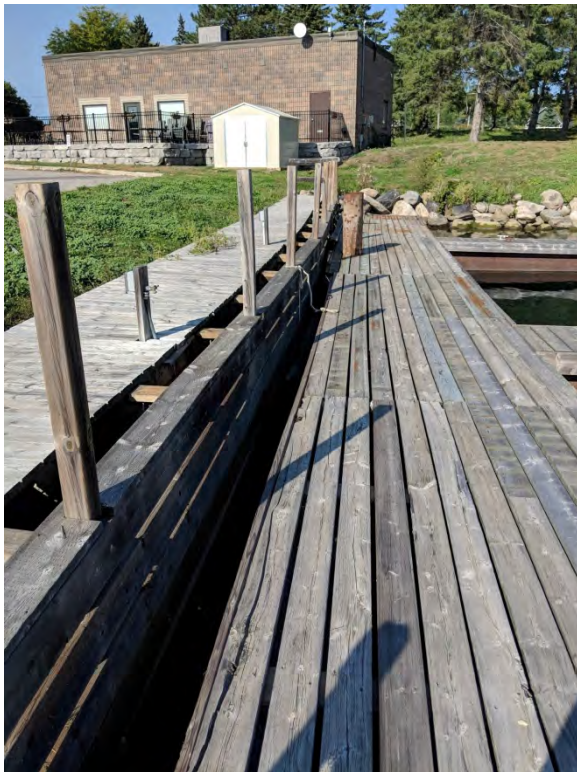
The north-south portion of this shoreline also has timber docks running parallel to shore with finger docks extending into the water perpendicular to the shore (Photo 4). There is a gap between the docks and the grassy shoreline that makes access difficult. Looking under the docks, there appears to be a timber lagging wall between steel posts that retains the shoreline. It is also in severe disrepair. No concrete cap is visible under the walkway. The area behind this wall is missing a significant amount of fill material causing the shoreline to gently slope towards the water.

Photo 4 – Segment 1 – Timber Docks Running North South

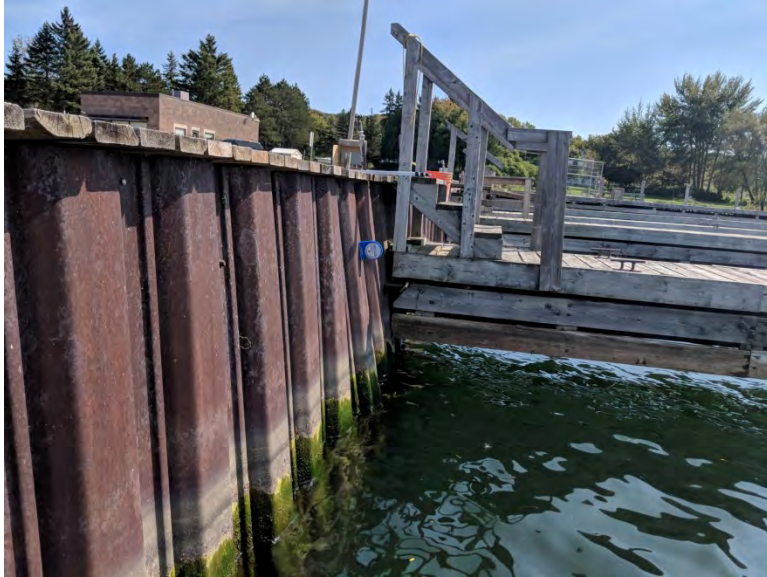
Along this segment of wall, running east to west, timber docks extend out into the water at regular intervals (Photo 5 and Photo 6). The docks are connected to the shore wall and supported on piles. The segment is approximately 78 m long. The wall consists of 460mm wide, 4mm thick steel sheet piles. 5/8" bolts are located approximately 300mm down from the top of the wall presumably connected to a wale on the back of the piles. Occasionally these bolts were slightly larger with a 3/4" diameter. The spacing of these bolts along the length of the wall is irregular, ranging from under 1.0m to 2.75m. The top of the wall was approximately 1.35 to 1.4m above the water level on the day of the inspection. This puts the top of wall at approximately 178m IGLD85. The walkway adjacent to the wall consists of timbers that sit perpendicular to the wall. The timbers extend over the top of the wall and approximately 2m inshore.

It was noted that the steel sheet pile wall had a slight lean to it. The top of the wall leans towards shore at a varying angle of 1 to 7 degrees along its length. Typically, a 0.5 degree lean is an acceptable installation tolerance. There were parts of the wall that did not extend up to the underside of the timber deck that sat above it. There were also small sections of patchwork repairs noted along the face of the wall. Near slip 128 (the 6th finger in from the east), a hole was created at the top of the wall by a pile cut shorter than the top of the wall. This made it possible to see the stone fill, wailer and tie rods behind the wall and under the deck (Photo 7). The section of wailer that could be seen is severely corroded. Although tie rods were seen it

A number of observations lead us to conclude that the steel sheet pile wall does not provide suitable shore protection. These observations include a portion of wall that bows out indicating failure, poor condition of the wale, low elevation of the crest and the significant lean along some areas of this sheet pile wall. The wall is considered to be at its end of life and in need of replacement.

Photo 5 – Segment 2 – Sheet pile wall

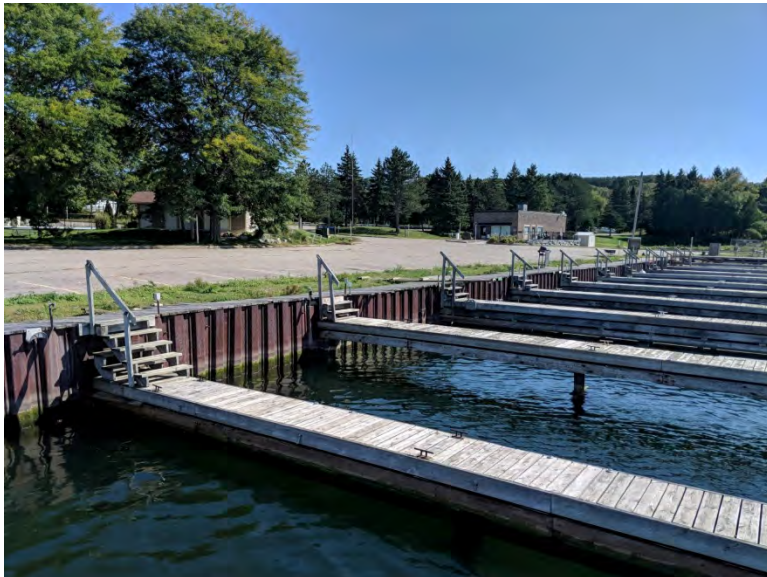
Photo 6 – Segment 2 – Dock Extending from Sheet Pile Wall

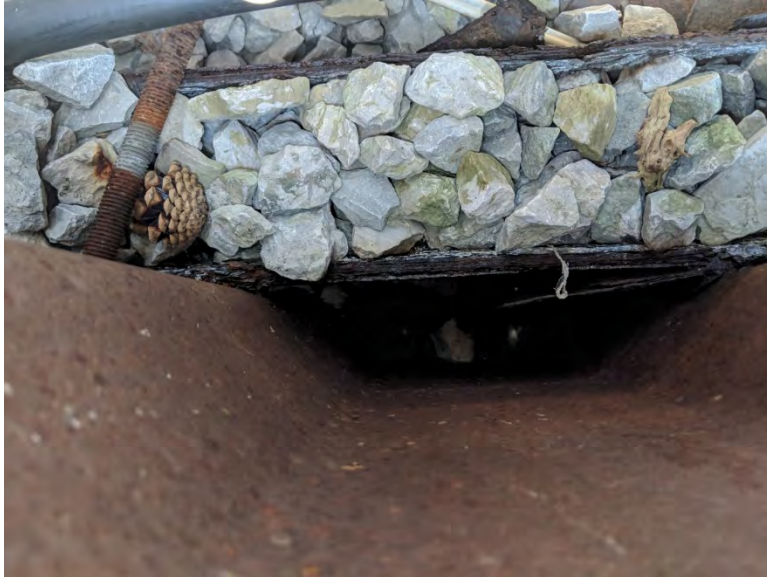
Photo 7 – Segment 2 - Fill Material Behind Wall

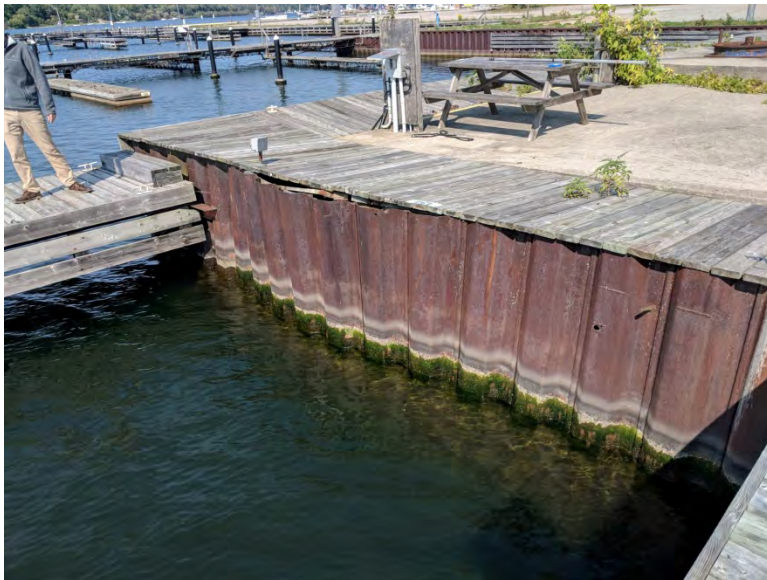
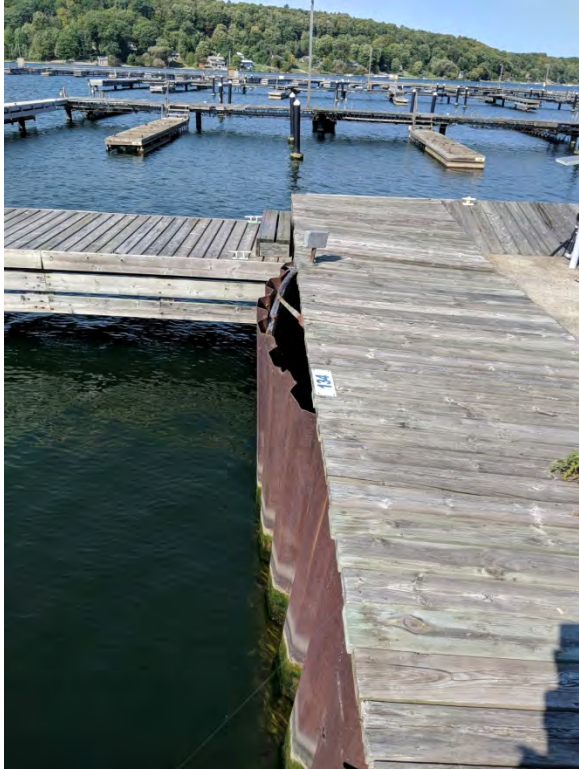
A bow out of approximately 300mm was noted in the wall at the west end. This extended for approximately 3m at the west end of this segment of shoreline. This is considered a failure of the wall (Photo 8 and Photo 9).

Photo 8 – Segment 2 – Failed Area

Photo 9 – Segment 2 – Close up Failed Area

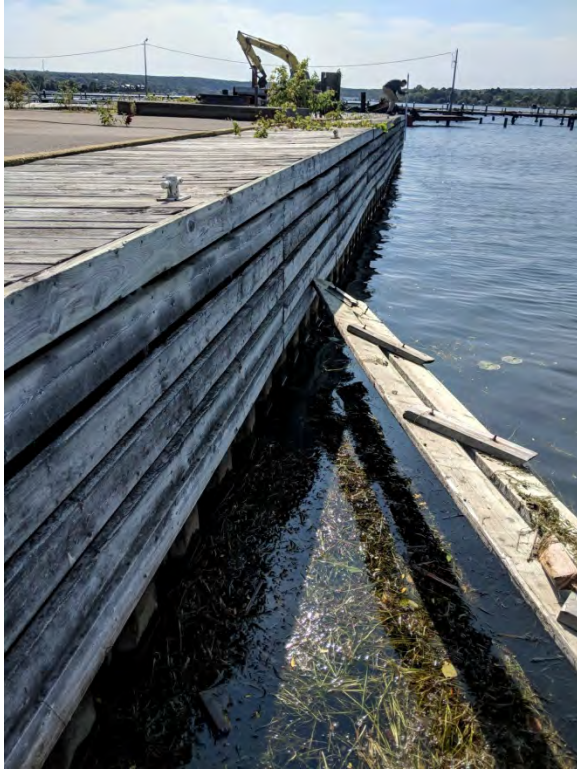
This segment of steel sheet pile wall runs more or less south to north. The segment is approximately 24 m long. The top of the wall is at approximately 1.4m above water level. This corresponds to an elevation of approximately 178.1m IGLD85. The face of the wall is covered in 2x6" horizontal timbers from the top of the wall to 1m down (Photo 10). It was not possible to measure the angle of lean, if any, or see the condition of the steel sheet piles due to the timbers. The timber face was near vertical with no consistent lean in or out. Looking between the timbers and wale bolts could be seen. The bolts along this wall were irregularly spaced, as with the previous segment. The spacing ranging from approximately 1m to almost 5m. No tie rods were visible on the outside of the wall.

Photo 10 – Segment 3 – Timber Faced Wall

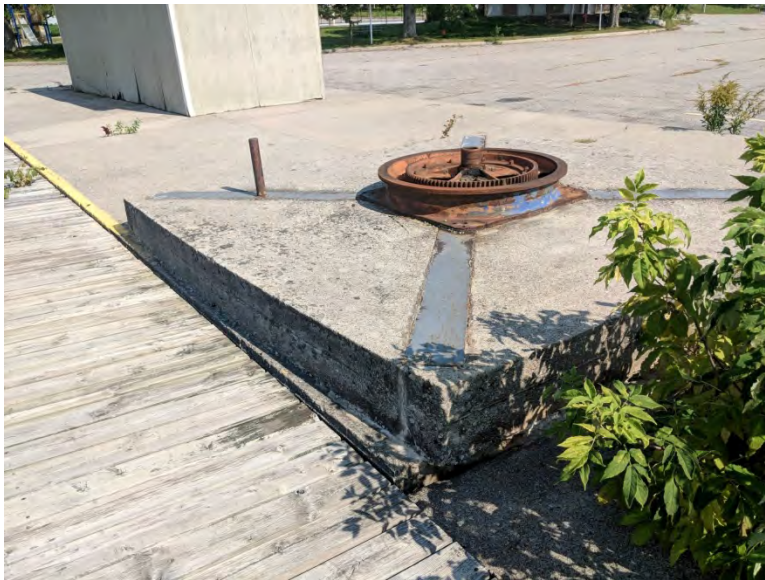
The backshore at this location has a timber walkway along the length of the wall and a concrete pad near the south end inshore from the walkway. There is a paved parking lot on the north end and inshore from the concrete pad (Photo 11). This is the only segment of wall that does not have a grass area adjacent to the walkway. The edges along the concrete pad are broken and the west side is sunken into the ground approximately 50 to 100mm. The timber walkway along the edge of the wall slopes towards the water at up to a 10degree angle near the north end. This angle is only 5 degrees around the concrete pad and 3 degrees at the south end of the wall.

The condition of the pathway and concrete pad adjacent to the wall indicates there is movement in the backshore of this segment. It could not be confirmed that this is due to wall movement but it is reasonable to assume it might be. Due to the timbers facing the wall the condition of the steel sheet pile wall could not be entirely assessed. Based on the backshore condition, this segment of wall is most likely suffering the same deficiencies as the segment 2 wall.

Photo 11 – Segment 3 – Concrete Pad

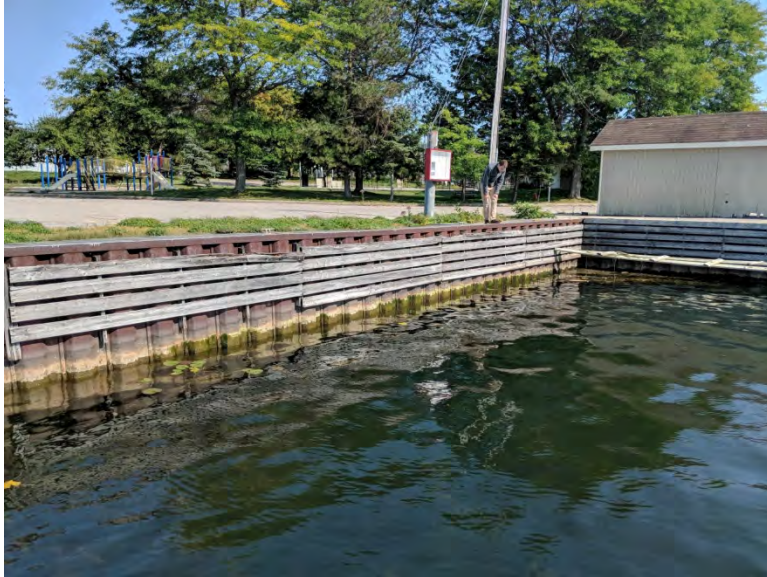
The wall was measured to lean in at the top 1 to 4 degrees at the south end where the top of wall is at 1.4m from the water line (178.1m IGLD85). At the west end of this segment the top of the wall is lower. It extends only 1.1m from the water line (177.7m IGLD85), as seen in Photo 13. At this location the top of the wall also leans out one degree.

There is no evidence of failure in this segment of wall however the lean to the wall suggests movement. The lower elevation of the west end is substantially below the design high water level for this area which is 178.0m GSC. This low elevation means it does not protect against flooding and the backshore would sustain damage during a design storm event. The remainder of the wall extends up to the design high water level but will be overtopped during design storms. Although the wall in this segment shows no structural deficiencies other than excessive lean, it cannot be established that the wall can be readily upgraded to provide the required flood protection.

Photo 12 – Segment 4 – Steel Sheet Pile Wall

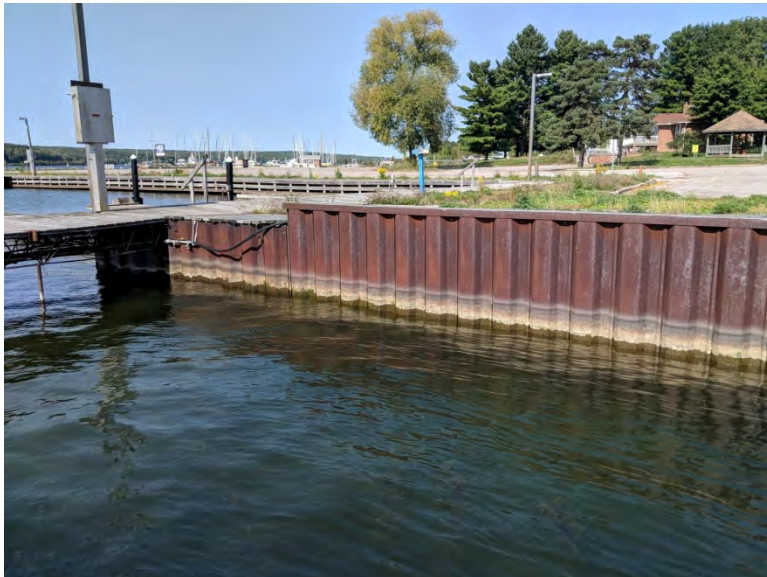
Photo 13 – Segment 4 – Lower End of Wall

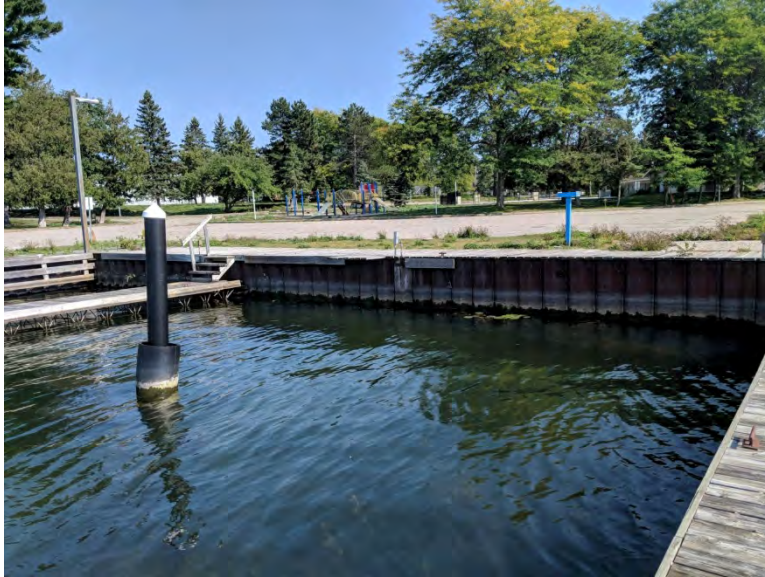
There is no sign of failure and the lean at the top of the wall is minor in this segment. As with the previous segment this wall is below the design high water level and would be overtopped during a high water event which could cause damage to the backshore. In this condition the wall is considered under designed for the area's coastal conditions. Although the wall in this segment shows no structural deficiencies, it cannot be established that the wall can be readily upgraded to provide the required flood protection.

Photo 14 – Segment 5 – Steel Sheet Pile Wall

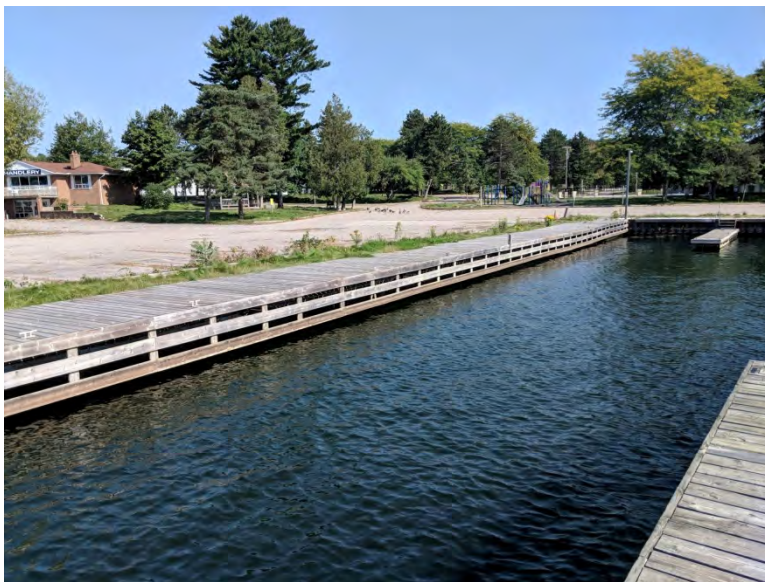
This segment of wall turns west and runs for approximately 71 m long. Access to this segment of wall was restricted due to the pile supported deck in front of the wall. The edge of the pile supported deck is then faced with timber which obstructed a clear view under the piled deck towards the wall. The inspection was completed using a high definition video camera taking continuous video of the wall between the horizontal timbers of the outer timber fenders. A review of the video indicates that the construction of this steel sheet pile wall is similar to that in reach 5 with a couple of exceptions. We observed no wailer bolts on the sheet piles. If present they would have to be very close to the top and obstructed by the deck structure or very low and be below water. Both conditions would be different than construction details in other part of the site. There were, what are likely anchor rods protruding through the wall at irregular intervals. The rods has a random piece of steel, typically a channel or plate, secured on the rod at the wall which appeared to be acting as a bearing plate. The rods extended a random length beyond the wall, in most cases 0.5m to 1.5m. No holes in the steel sheet piles or improper joints between the piles were noted.

The verticality of the wall could not be measured, but not obvious misalignment was noted. The top elevation of the wall remains the same as the previous segment. As noted in the other segments this puts the top of wall below the design high water level and as such the wall is considered under designed for the area's coastal conditions.

Photo 15 – Segment 6 – Timber Faced Timber Deck In Front of Wall

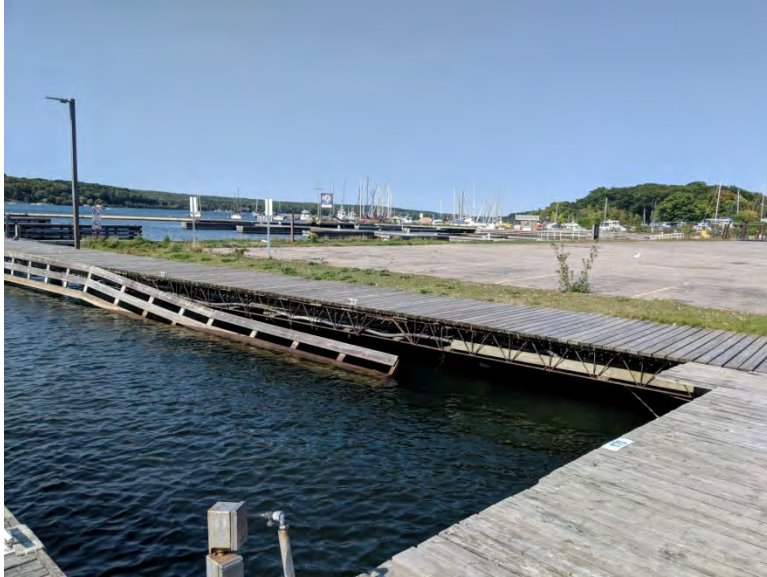
Photo 16 – Segment 6 – Timber Deck In Front of Wall

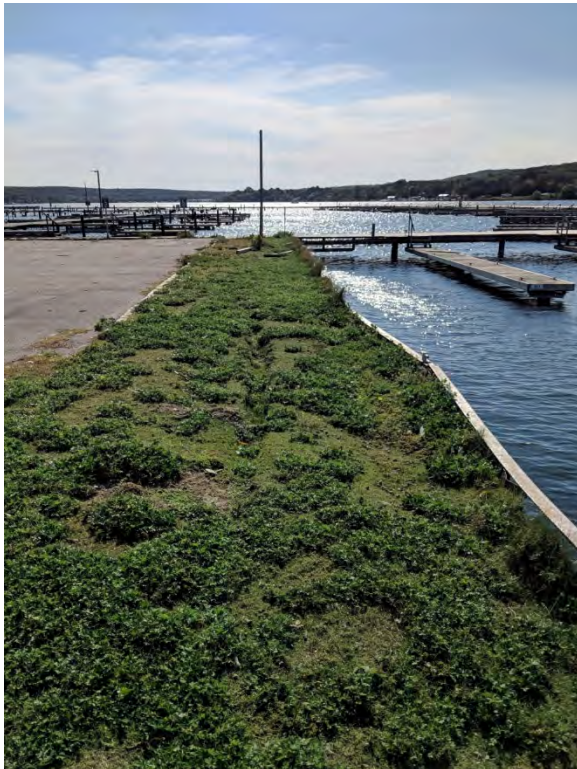
The first 10m at the south end of the wall has a lean out at the top of the wall of approximately 2 degrees. After this point there is a failure of the wall that extends over approximately 5m of length (Photo 17). At the centre line of the failure the wall leans 6 degrees out at the top. Approximately 0.25m deep depression has formed behind the failed wall. The wall is plumb on the north side of the failure.

This segment of wall has failed on the south end of the segment. In our opinion, the Z pile and plate segment is also unsuitable protection and will require replacement. The top elevation of the wall is also below design high water level along its entire length meaning it is unsuitable for the design coastal conditions. The backshore is susceptible to flooding.

Photo 17 – Segment 7 - Failed Area

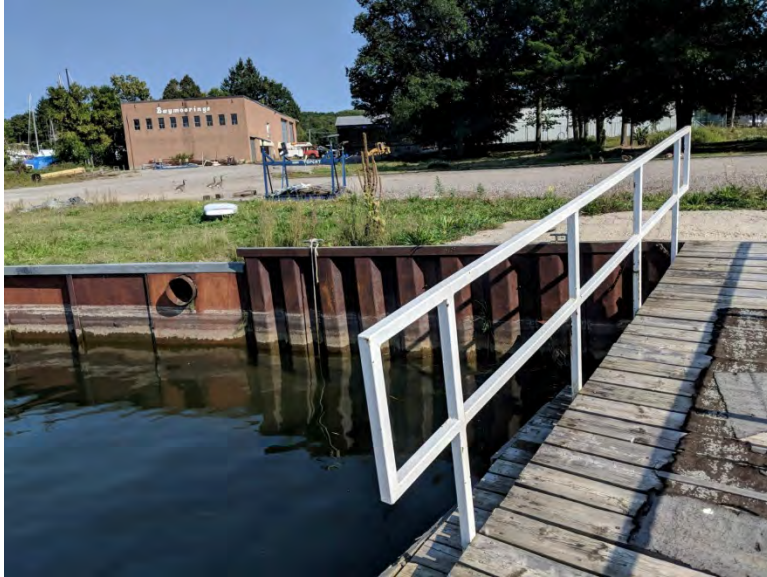
At the north end of the wall the construction changes from steel sheet piles to a 6mm thick by 1.2m wide plate held in place by vertically driven steel z-sections placed at the ends of the plate (Photo 18 and Photo 19). There is one tie at the centre of each plate approximately 300mm above water level. There is also a steel cap on south end of the wall. It is not connected to the wall for approximately 10m at the north end of this section. A depression behind the wall is

located at the connection between the steel plate structure and the sheet pile wall to the south. The sheets are not tight with the vertical z-section at the north end of this segment

Photo 18 – Segment 7 – Transition to Steel Plate Wall

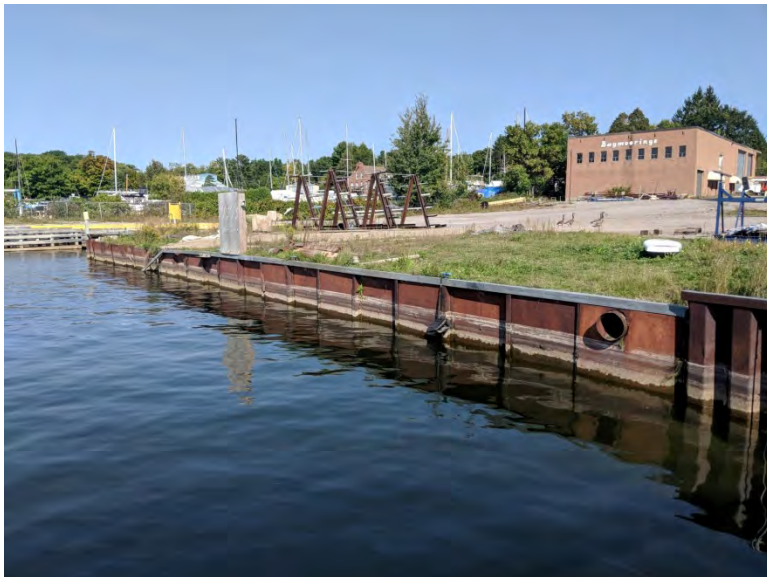
Photo 19 – Segment 7 – Steel Plate Wall

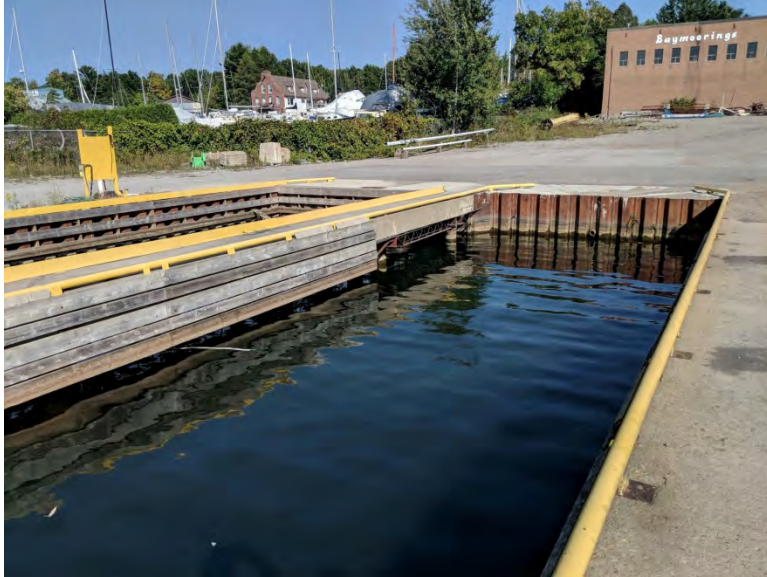
The marina area has two slips at the north end of the site (Photo 20). The two slips are separated by a pile supported “deck” which serves as the south travel ways. We assume that this pile supported structure will be removed and it was not reviewed.

The south wall in this section is unsuitable for shoreline protection for the same reasons as were noted in Segment 7. The newer east and north walls are in good condition with no signs of failure or extensive deterioration.

Photo 20 – Boat Slip Wall

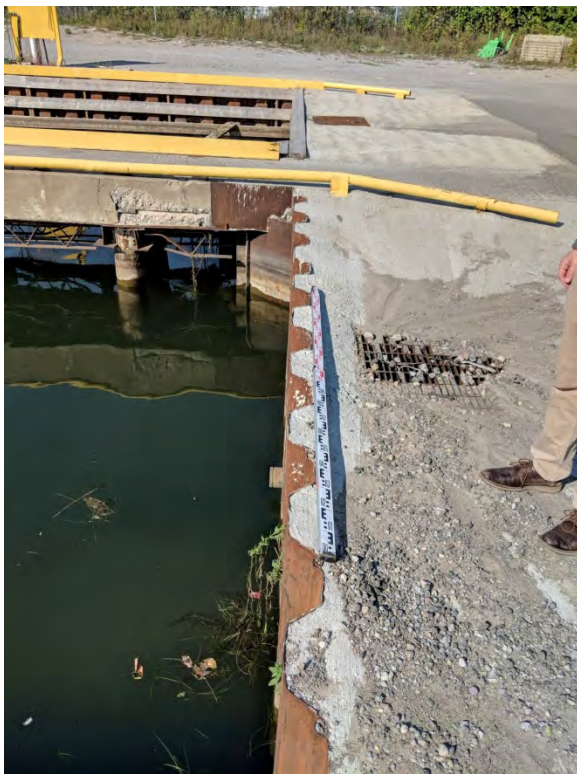
The east wall forms the ends of the slips (Photo 21). It appears to be constructed of newer steel sheet piles. The profile at this location is the same as the previous sheet piles. The backshore behind these sheet piles is poured concrete with a drainage grate (Photo 22).

Photo 21 – Boat Slip Wall Close up
