Re: Soil Sampling Program
160 – 200 Fox Street (Bay Moorings Marina), Penetanguishene, Ontario
Cambium Reference: 7856-001

This letter report summarizes the results of a soil sampling program conducted by Cambium Inc. (Cambium) at the above mentioned site. Cambium understands that the Client proposes to construct a subdivision at the site, and based on the findings of the geotechnical investigation by MTE Consultants Inc. (MTE) the dwellings are to be founded on helical piles.

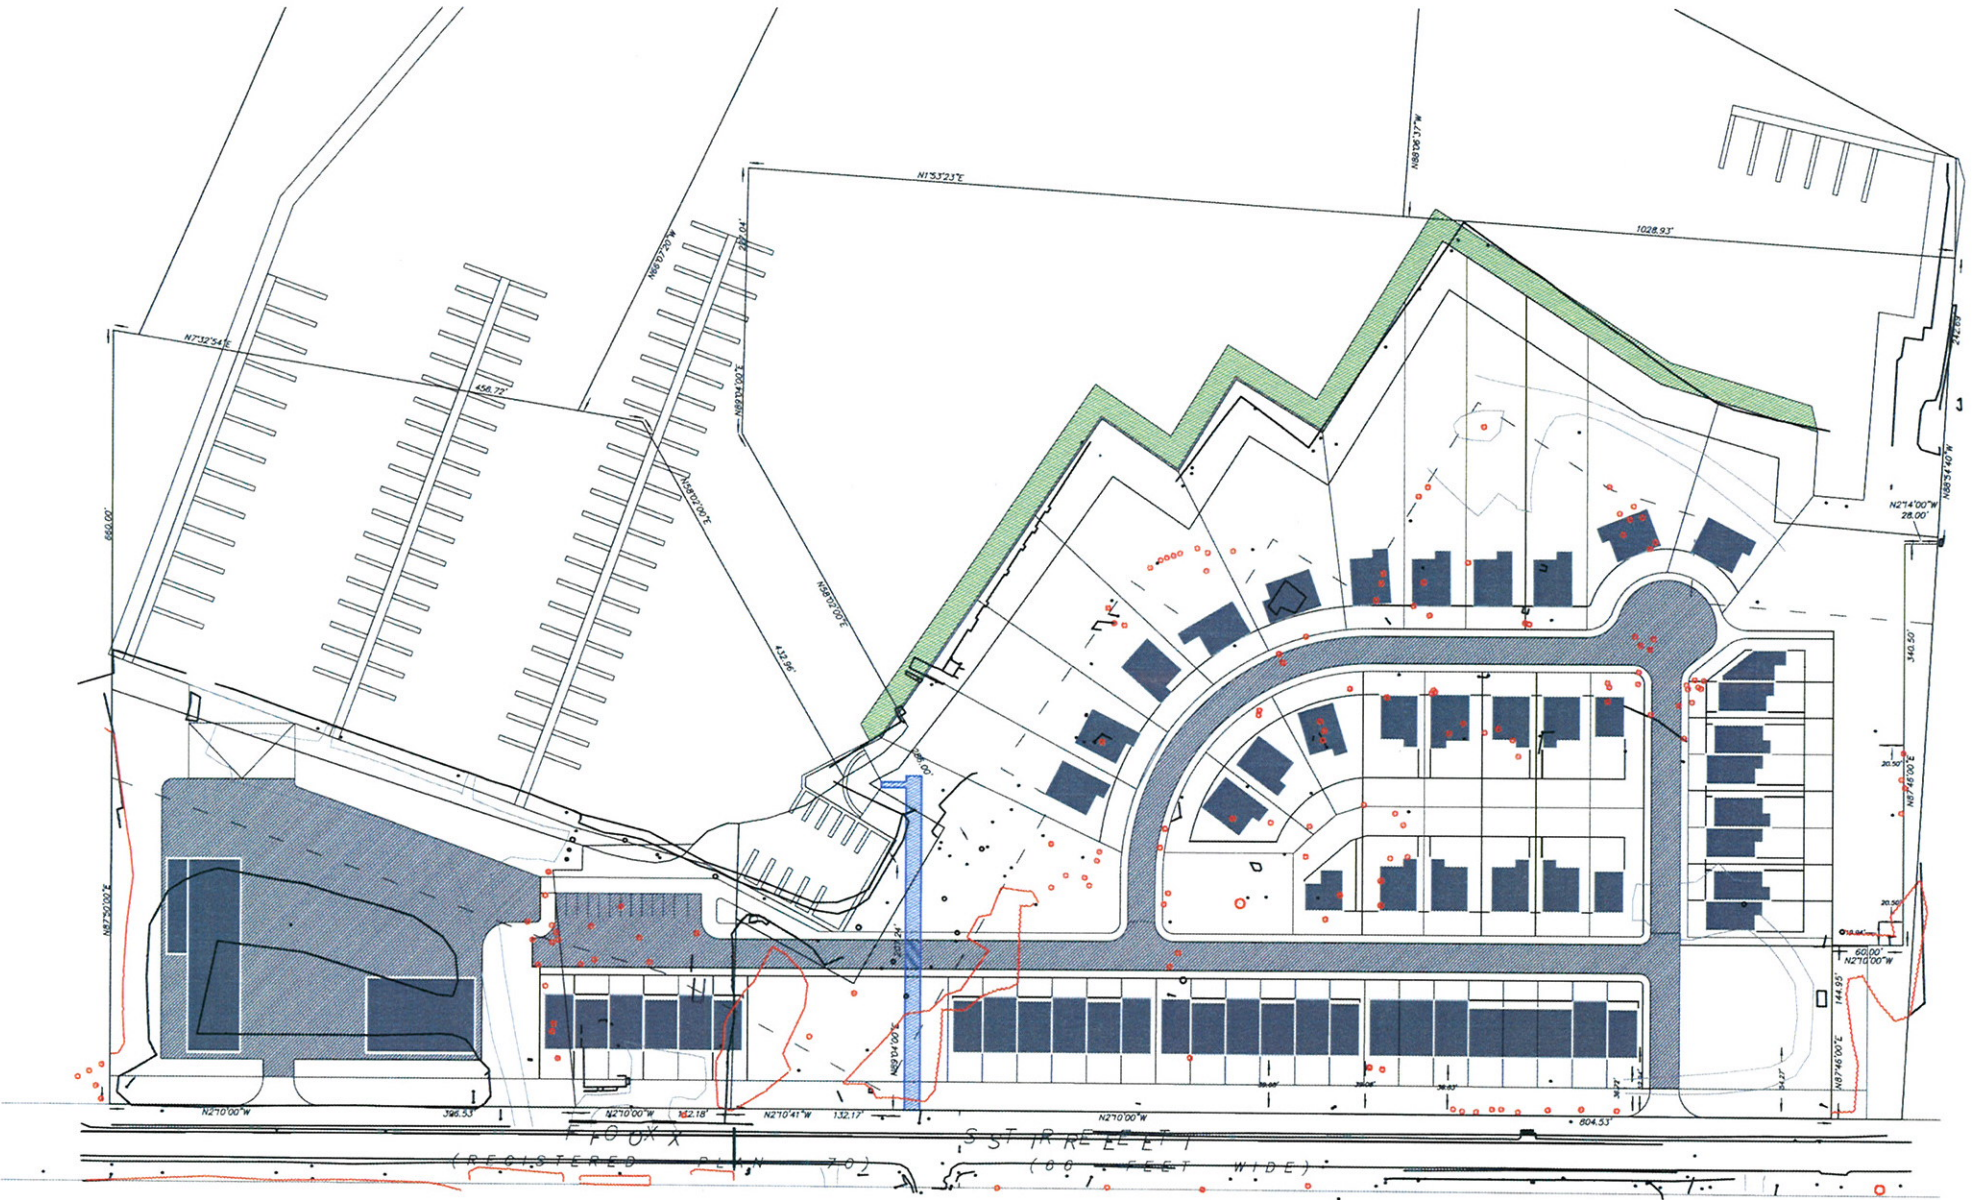
Encl. *Figure 1 – Test Pit Location Plan
Laboratory Test Results*

Five (5) test pits were advanced on the site in strategically placed locations surrounding the fill berm to determine the quality of the fill material. Test pits TP1, TP2 and TP5 were conducted on the existing berm and extended to a depth of ± 2.8 mbgs. Test pits TP3 and TP4 were conducted adjacent to the lake to a depth of 1.8 mbgs. A test pit location plan is appended to this letter as Figure 1.
