Bay Mooring Marina

Shoreline Natural Hazards and Condition Assessment

Shoreline Natural Hazards and Condition Assessment November 2018

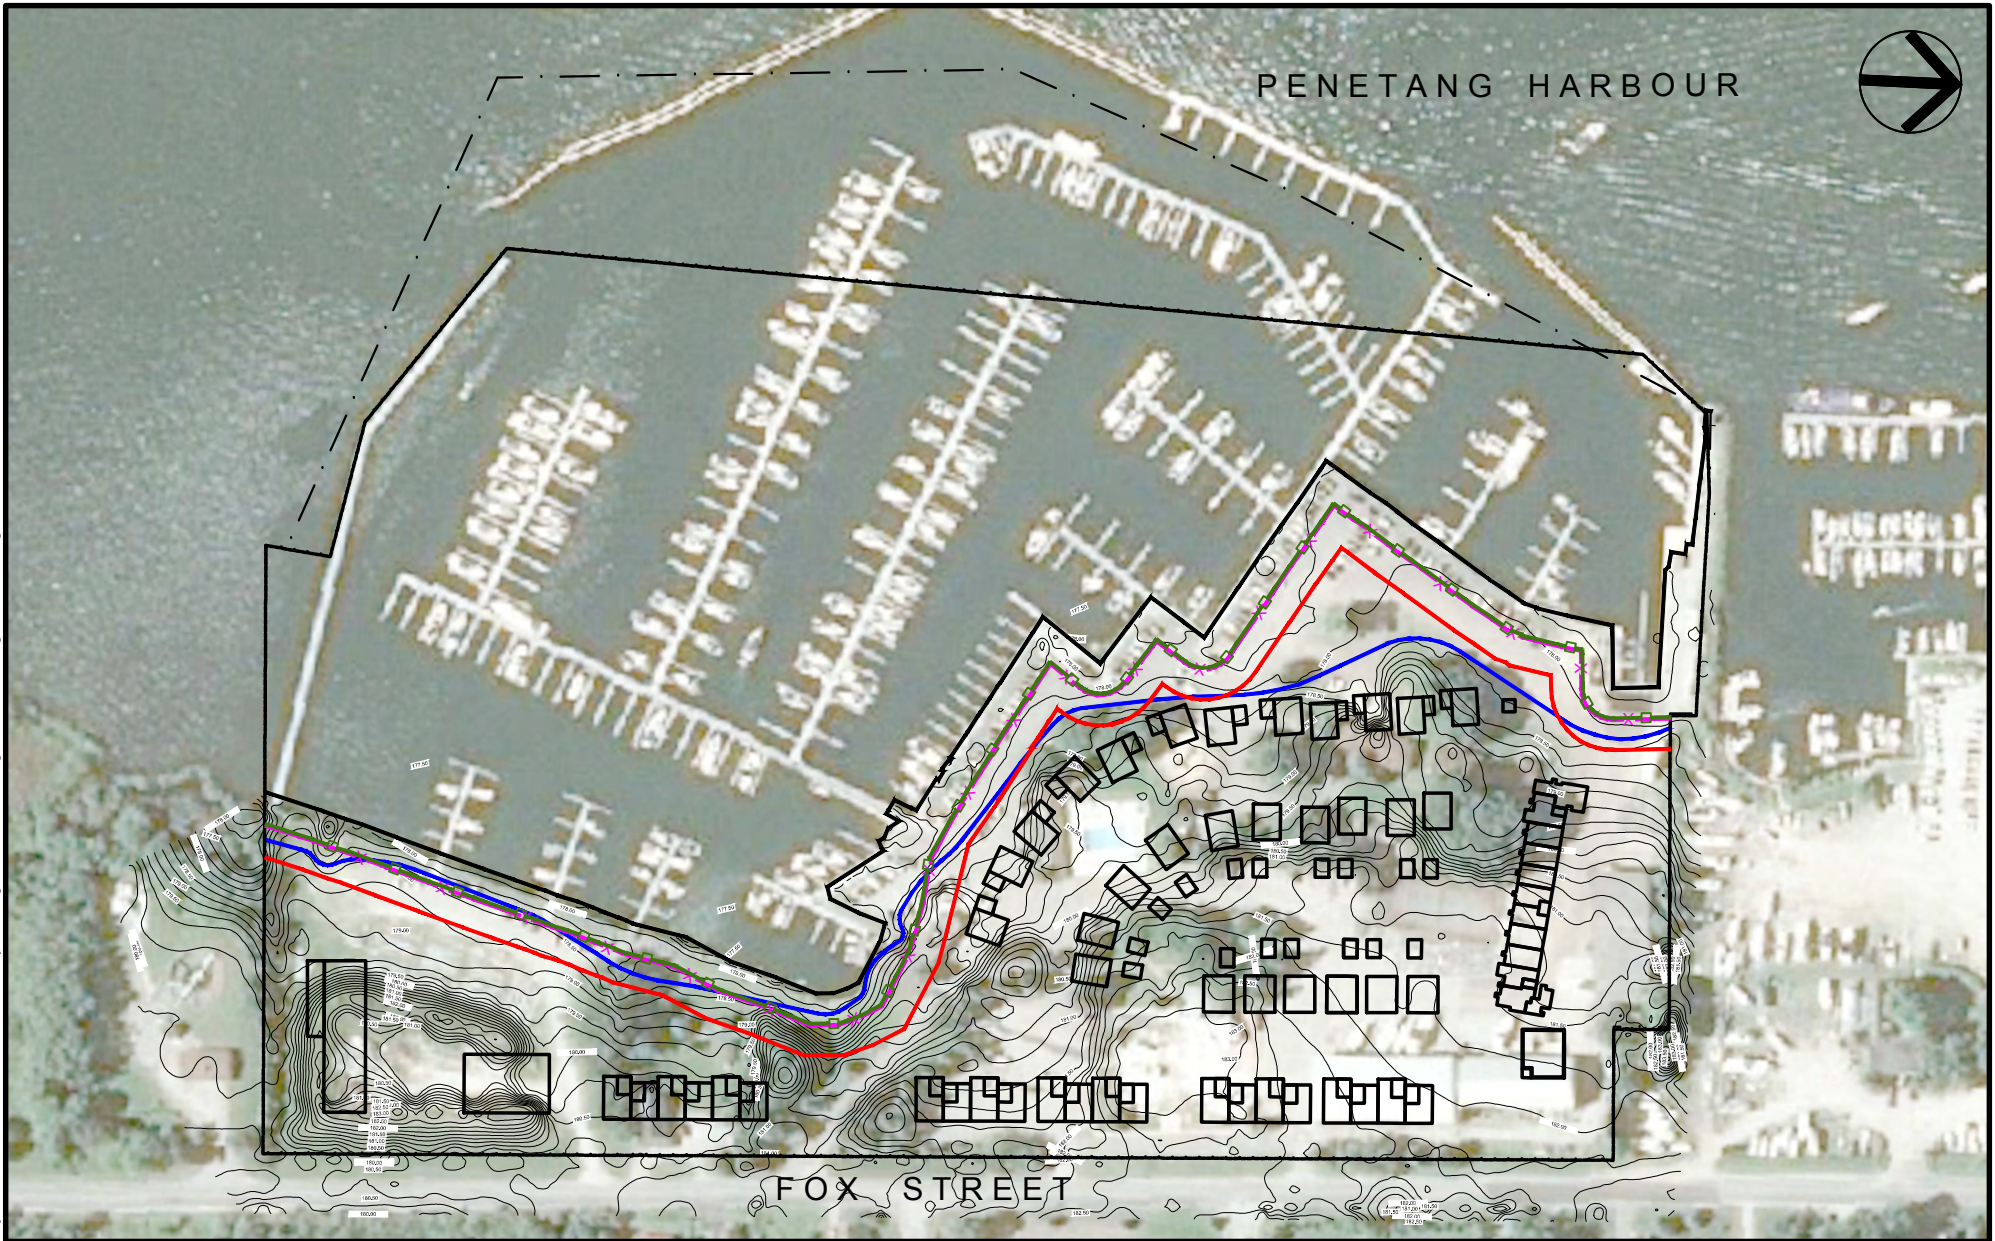
Figure 3
Bay Moorings Marina, Penetanguishene
Development Hazard Limits

Wave conditions around the site were input to a profile-based wave uprush program. Uprush was calculated for a number of representative profiles, and the wave uprush limit was interpolated between profiles giving regard to the site contours. Wave uprush beyond the 178.0m contour was minimal because that contour was some distance in from the existing shore protection walls, and those walls break the incoming waves. Water depths between the walls and the 178m contour were in the order of 0.3m or less, so only small broken wave bores reach the 178m contour. The calculated wave uprush limit, which defines the flood hazard limit, is shown on Figure 3.

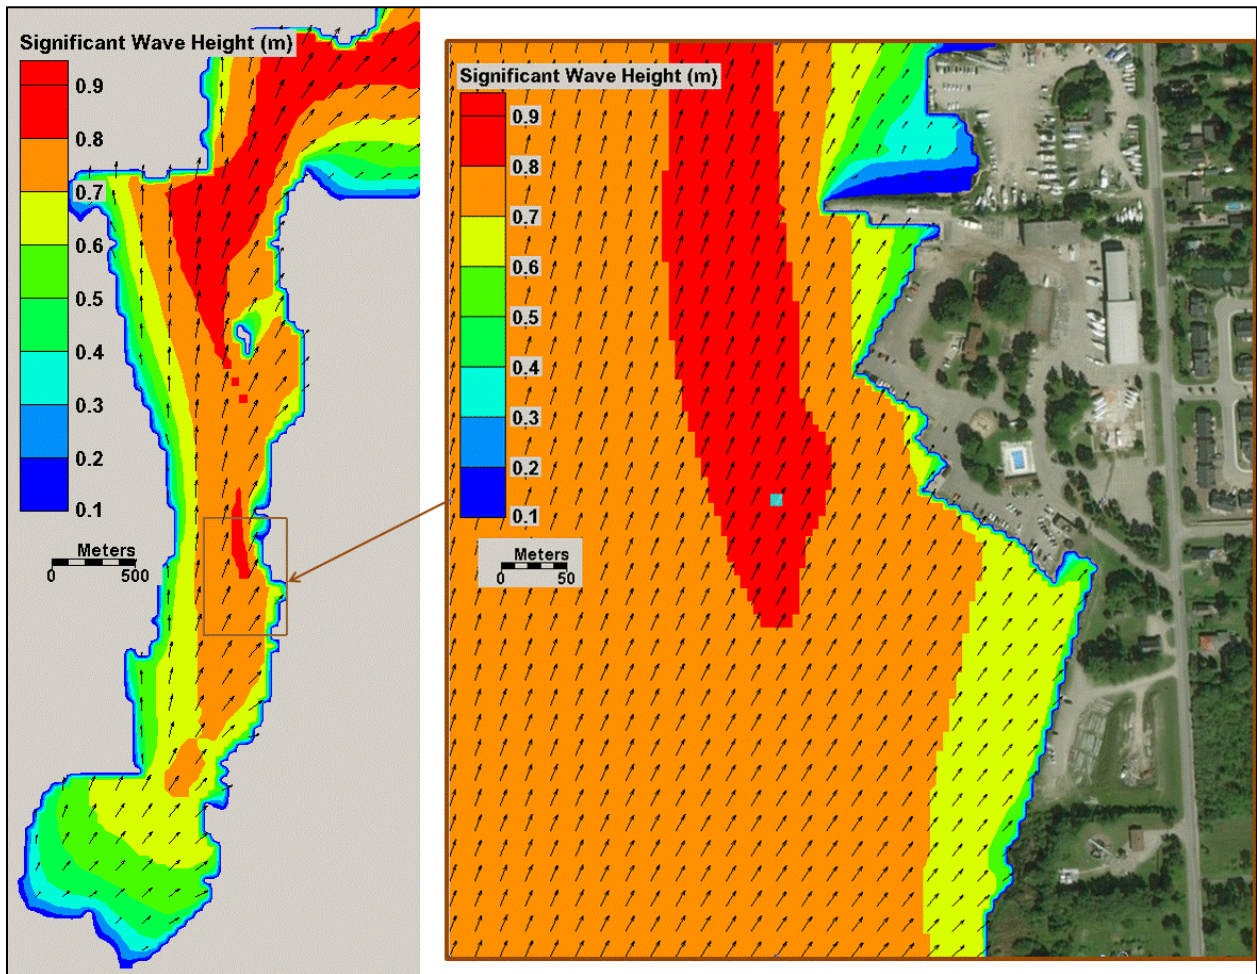
Figure 4 – Wave Model Results for Southwest Winds

MNR (2001) defines the flood hazard wave uprush elevation as that caused by a 20-year return period wave occurring at the 100-year flood level. The 20-year return period wave condition was estimated by modeling wave generation caused by a 20-year return wind using the SWAN spectral wave model developed by Delft Hydraulics. A total of nine wind directions were considered, ranging from south through to north at 22.5 degree intervals (therefore south, south-southwest, southwest, west-southwest, etc.). Figure 4 is a wave height contour and vector plot showing an example of the wave model results. Significant wave heights along the perimeter of the site ranged from 0.3m to 0.8m.
