# 1290 Sandy Bay Road

Town of Penetanguishene

## Functional Servicing Design Brief

August 2024  
File: 2403

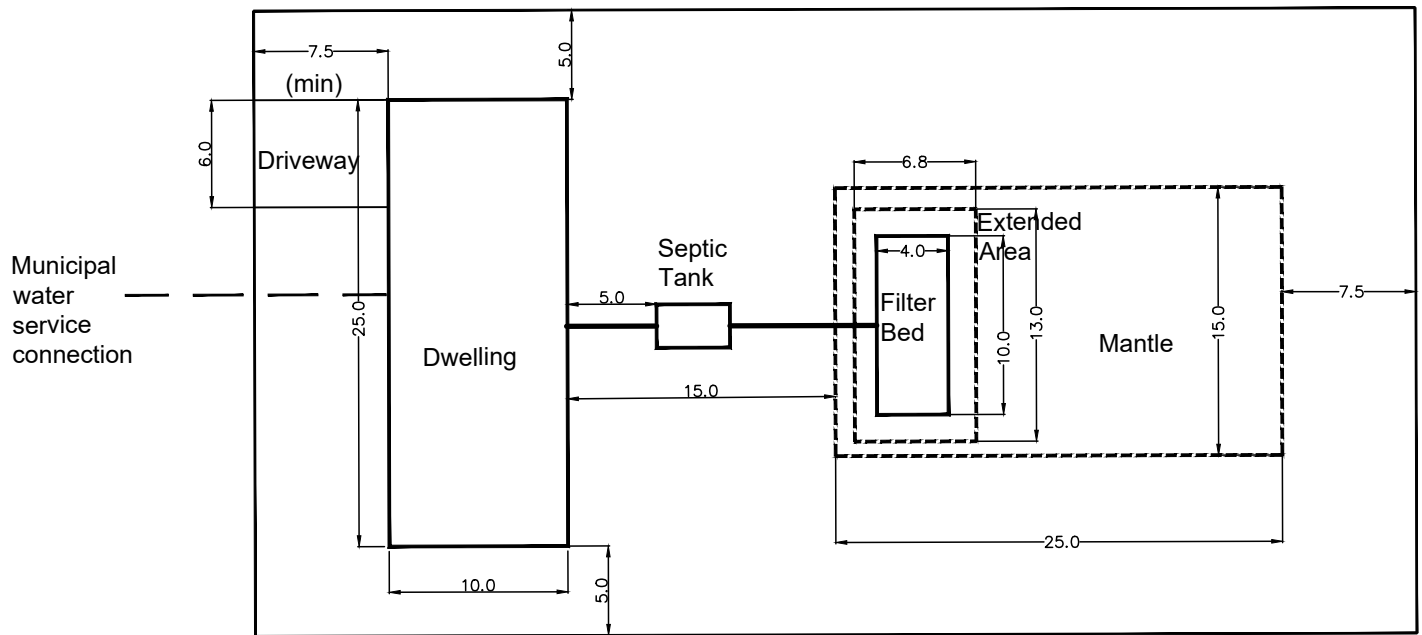
A sample configuration of this layout on a lot is shown in **Figure 2**. The assumptions are Filter Bed dimensions of 4m x 10m, with a 0.25m thick Extended Area of 6.8m x 13m and a 0.25m thick Mantle (including Filter and Extended areas) of 15m x 25m. The size of Mantle is the potential footprint of the septic bed system. Note that that configuration could be made slightly wider to

reduce the depth. However a minimum mantle of 15m downgradient of the last distribution pipe is required. The layout in the figure assumes a raised bed, 1m above existing grade, with 4:1 slopes down to existing grade.

- Figure 1                    Location Plan**
- Figure 2                    Typical Septic Bed Configuration**
